Project: National Paediatric Hospital

Report Type: Summary of Noise Vibration & Movement Monitoring

Period of Monitoring: 27th October – 22nd November

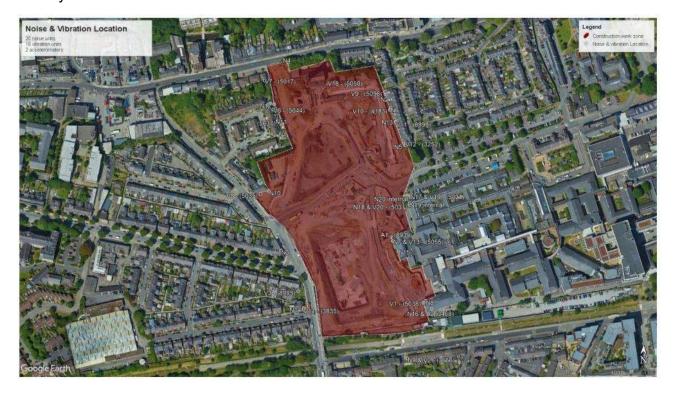
Location of Noise and Vibration Monitors

There are concentrations of monitors at the boundaries with Cameron Square and O'Reilly Avenue where works have been ongoing on site in proximity to neighbouring properties.
