**Project:** National Paediatric Hospital

**Report Type:** Summary of Noise Vibration & Movement Monitoring Results

**Period of Monitoring:** 13<sup>th</sup> January 2020 – 17<sup>th</sup> February 2020

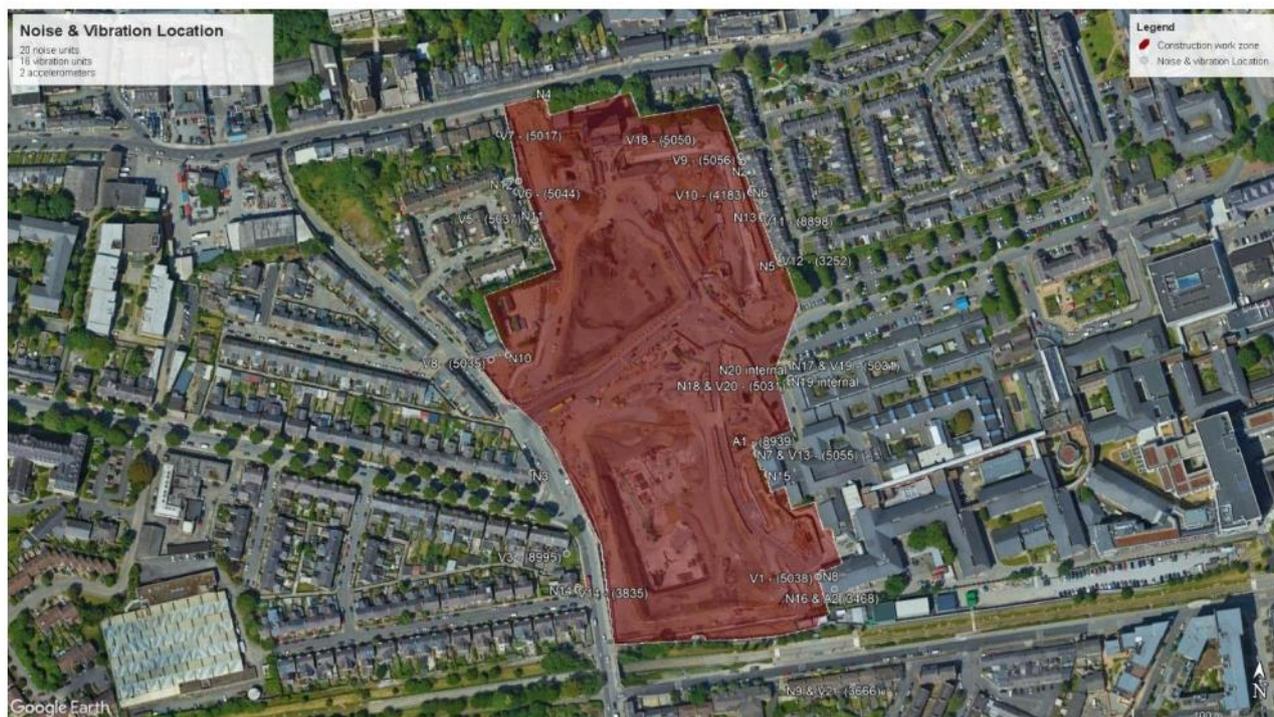
Location of Vibration Monitors

The layout of the monitors is as seen below:

There are concentrations of monitors at the boundaries with Cameron Square and O'Reilly Avenue where works have been ongoing on site in proximity to neighbouring properties.
